# **TMS320F28379S, TMS320F28377S, TMS320F28376S, TMS320F28375S, TMS320F28374S Delfino Microcontrollers**

## **Silicon Errata**

Literature Number: SPRZ422D  
August 2014–Revised July 2016

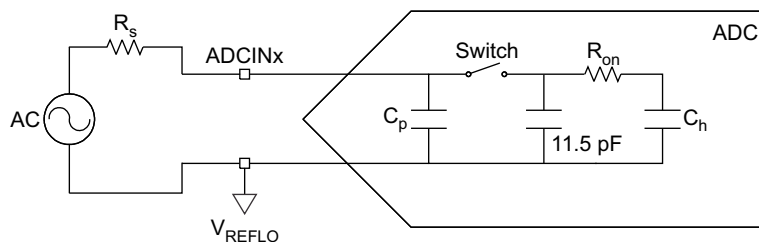
**Figure 3. Single-Ended Input Model**

**Advisory** ***ADC: 12-Bit Input Capacitance When Switching Channel Groups***

**Revision(s) Affected** B

**Details** The ADC input model should be used to select the sample-and-hold (S+H) duration for each ADC input. For the revisions affected, if the currently converting channel is an even-numbered channel and the previously converted channel was an odd-numbered channel (or vice versa), then the 12-bit input model will not accurately predict ADC input performance. Under these conditions, an additional capacitance should be added to the model. This capacitance has a value of 11.5 pF and should be placed between the S+H switch and  $R_{on}$  as shown in [Figure 3](#).

**Workaround(s)** For the revisions affected, when subsequent conversions switch between channel groups, the S+H duration should be chosen to account for the additional capacitance.
